Yellowstone National Park

Submerged Resources Survey

Submerged Resources Center
Professional Reports
Number 16

Submerged Resources Center
Intermountain Region
National Park Service

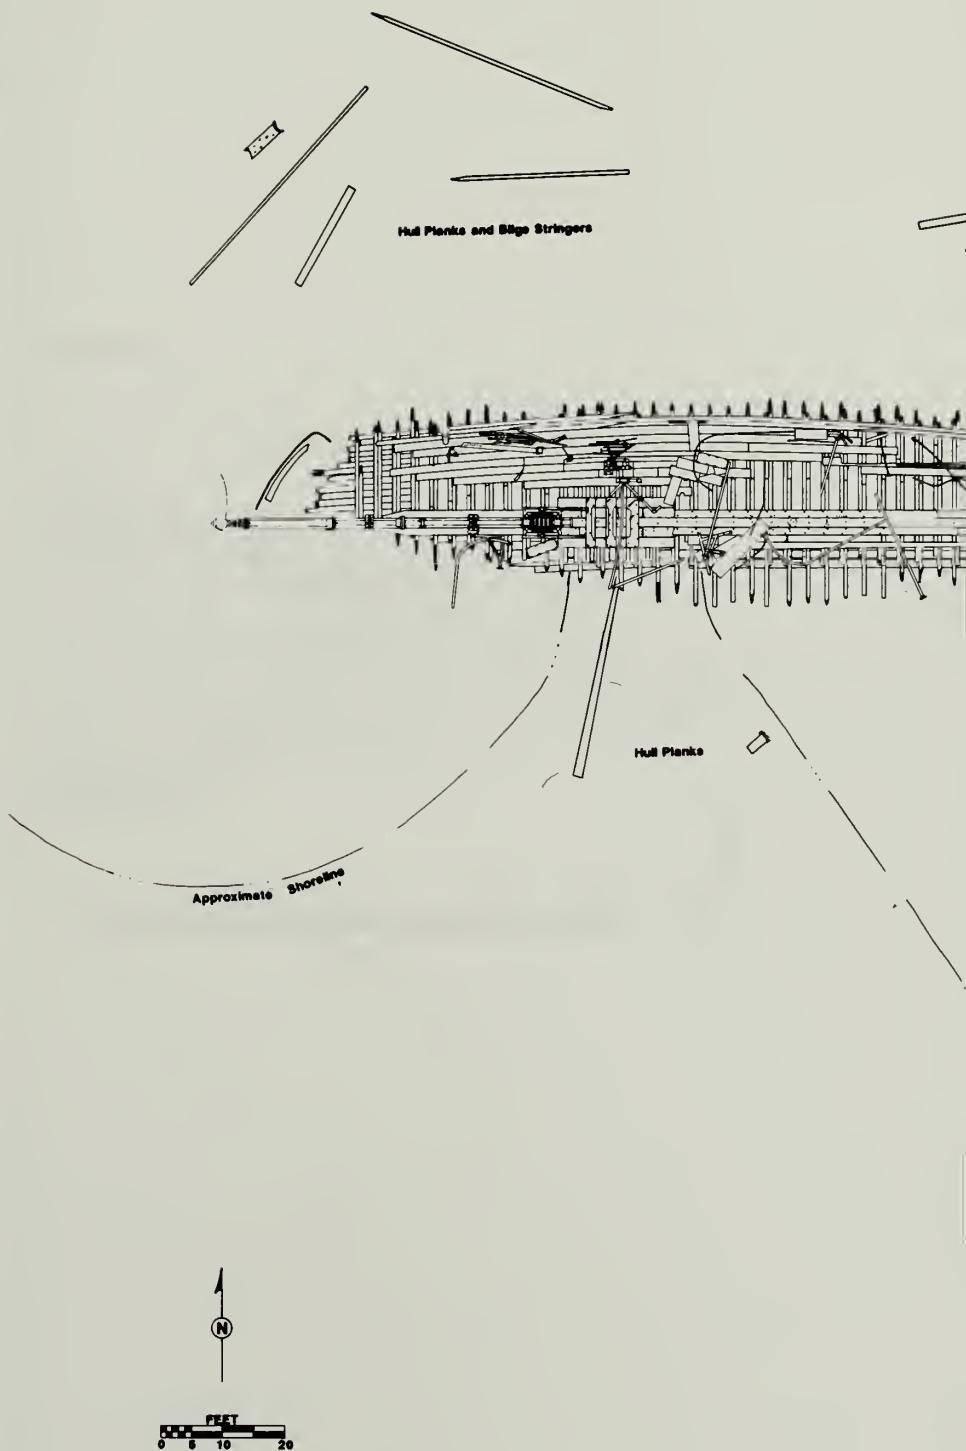
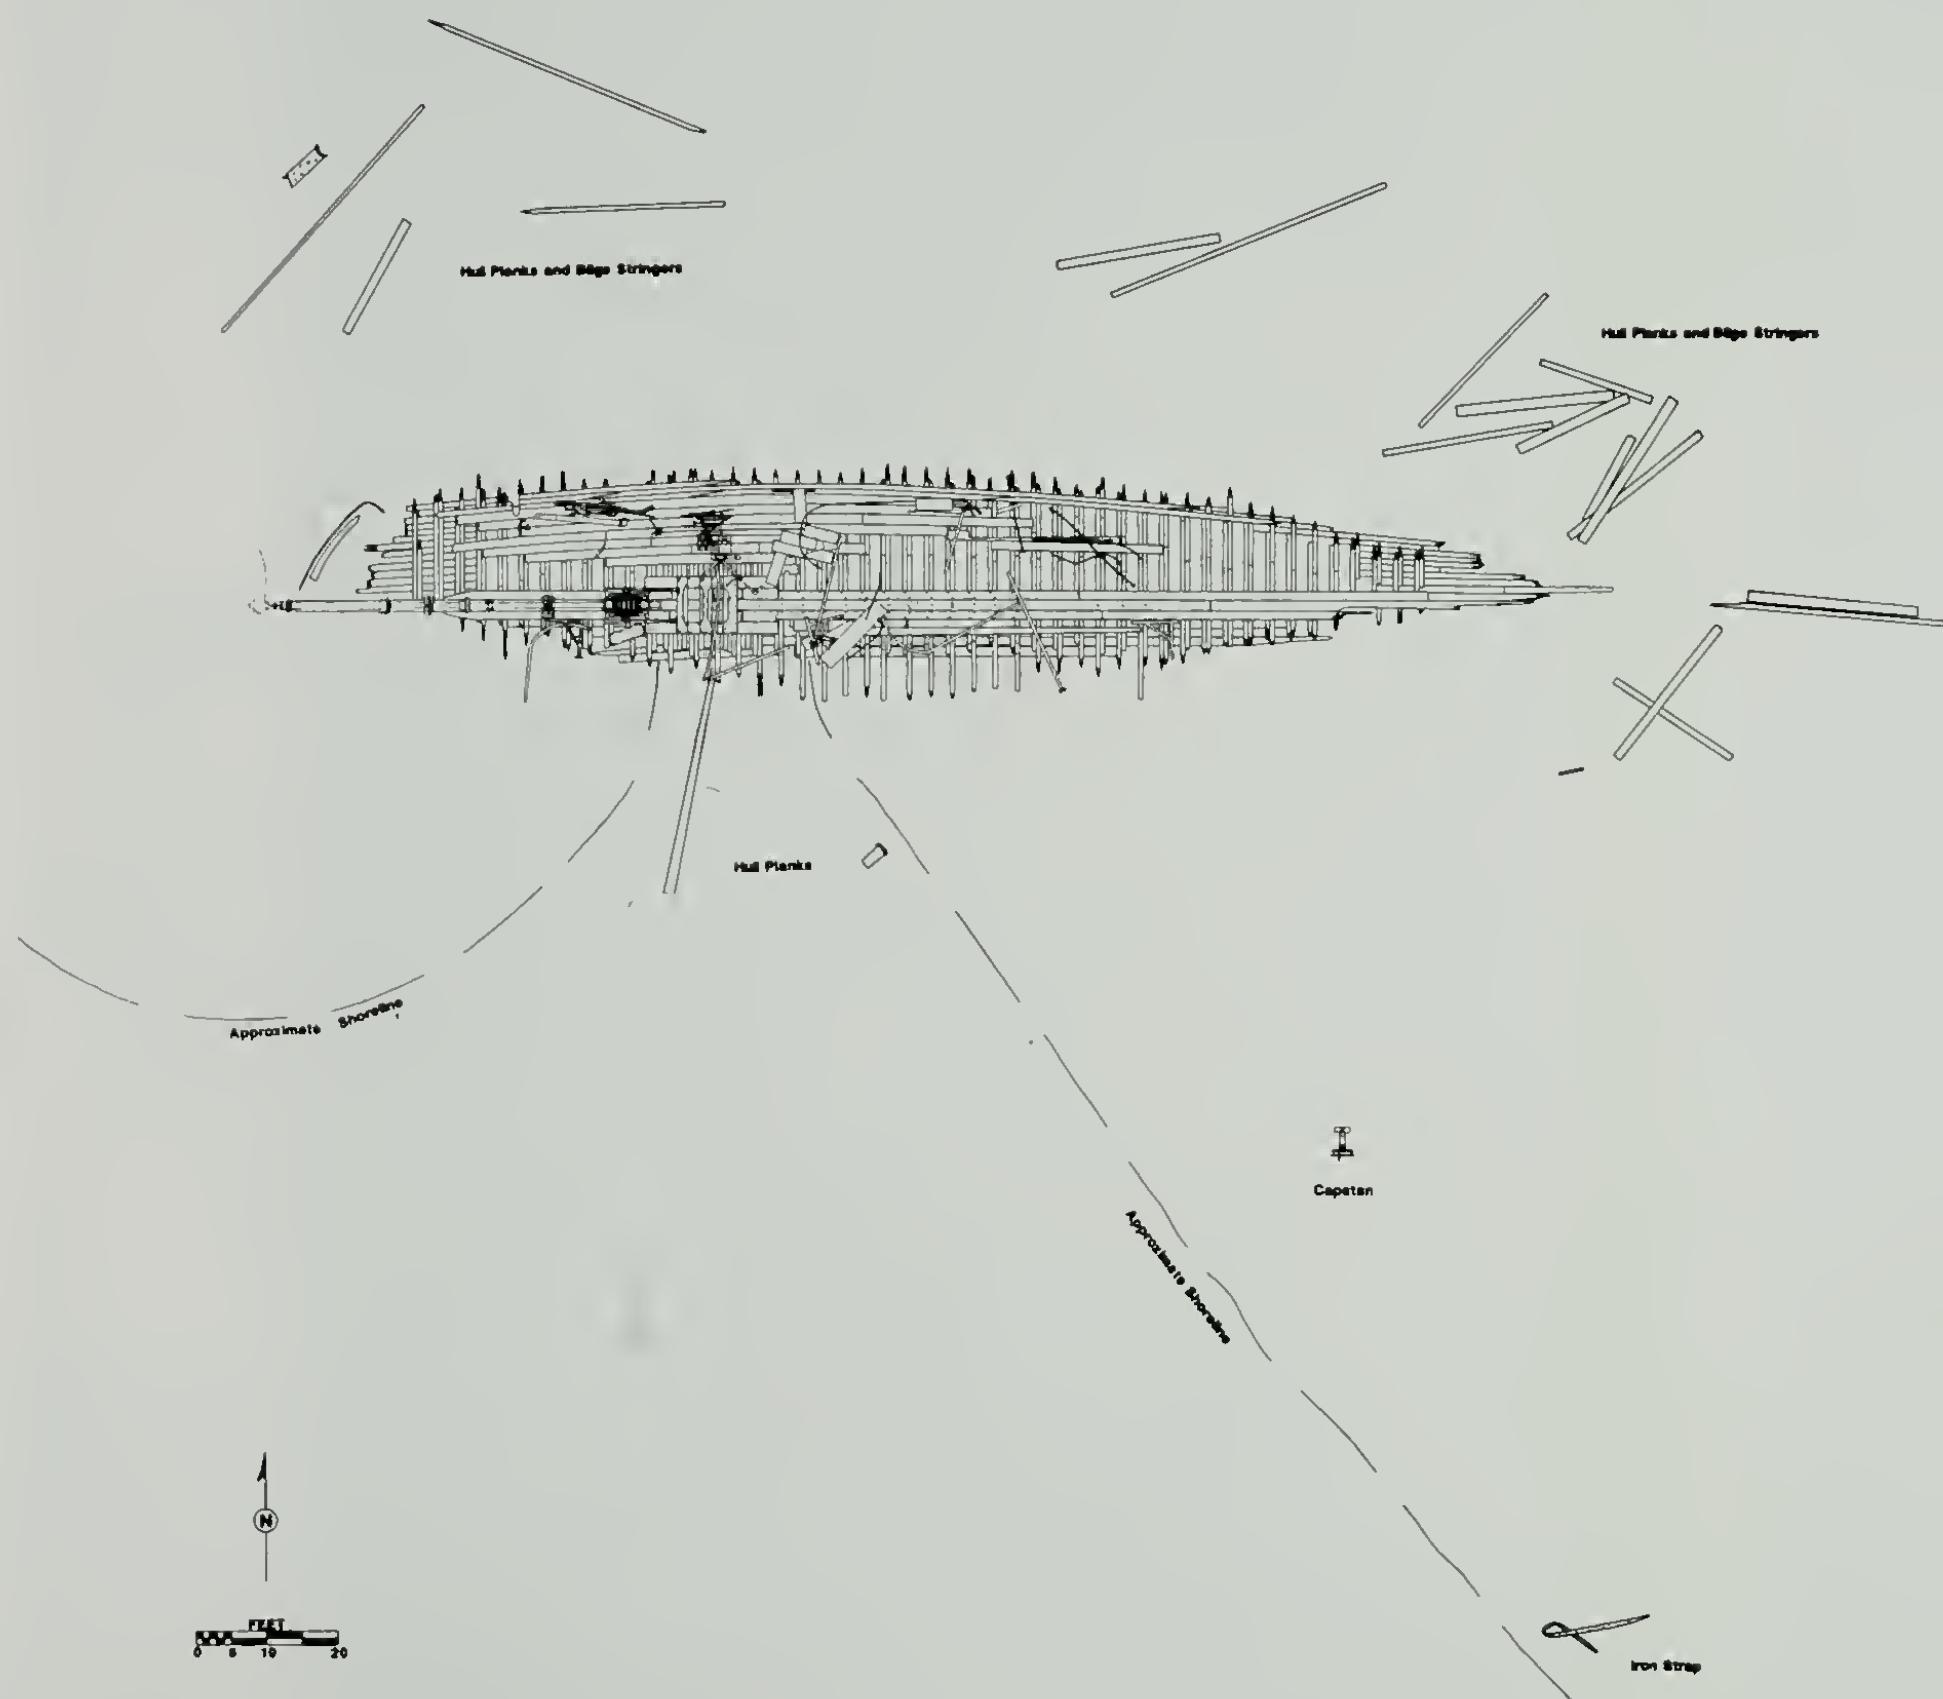
Figure 5.27. Plan view of *E. C. Waters*' site (48YE13). Drawing by Jim Bradford and Matt Russell.

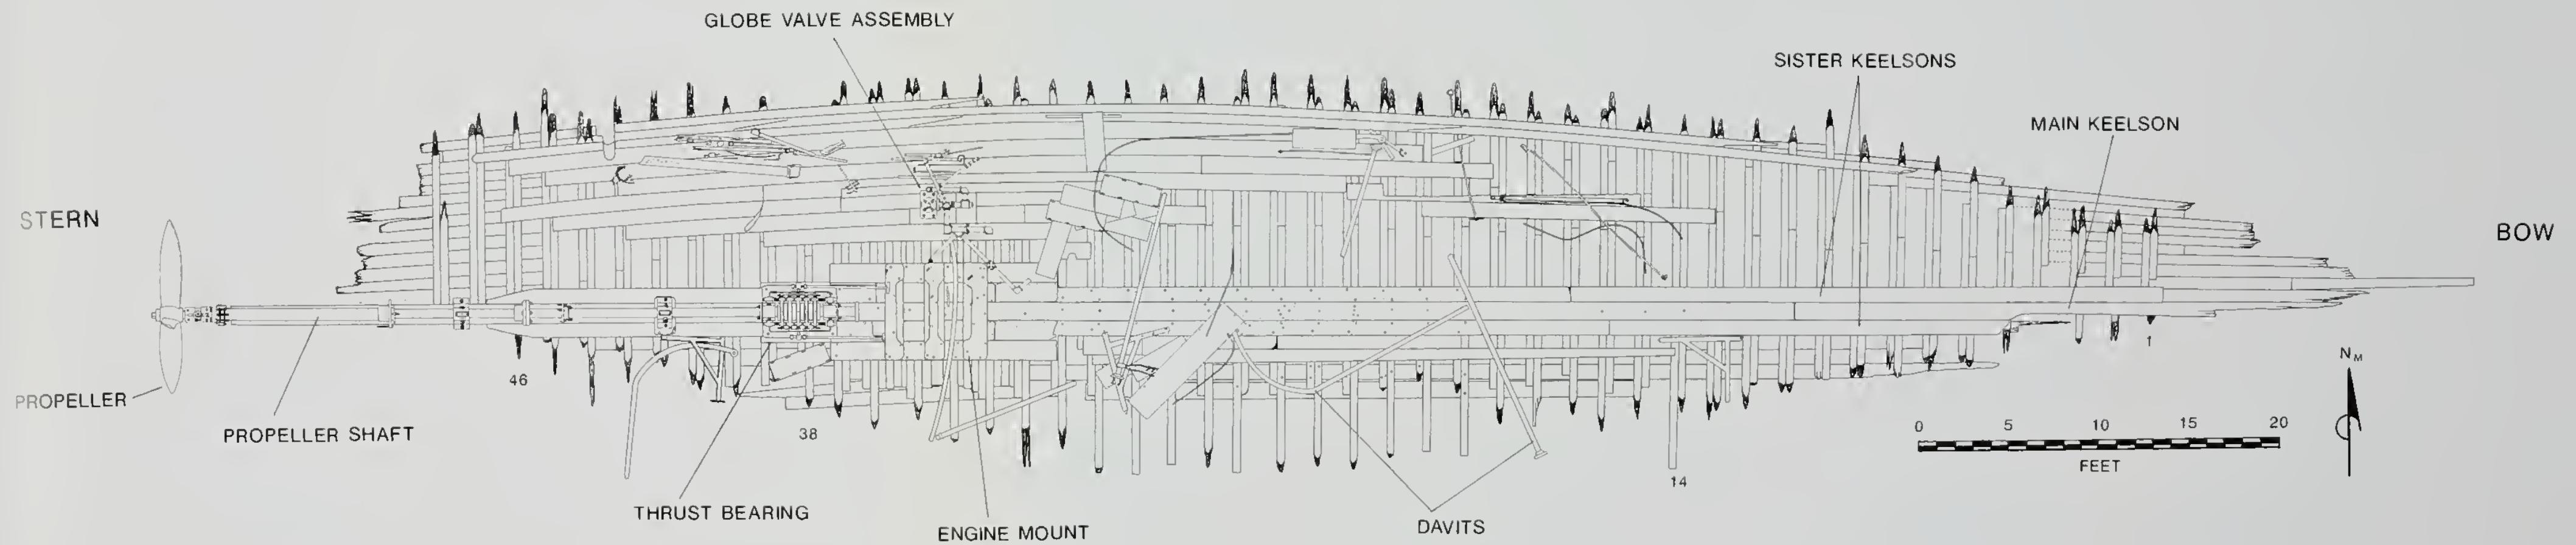
Figure 5.28. Plan view of *E. C. Waters*' hull remains. Numbers along the lower edge are frame pair numbers. Drawing by Jim Bradford and Matt Russell.

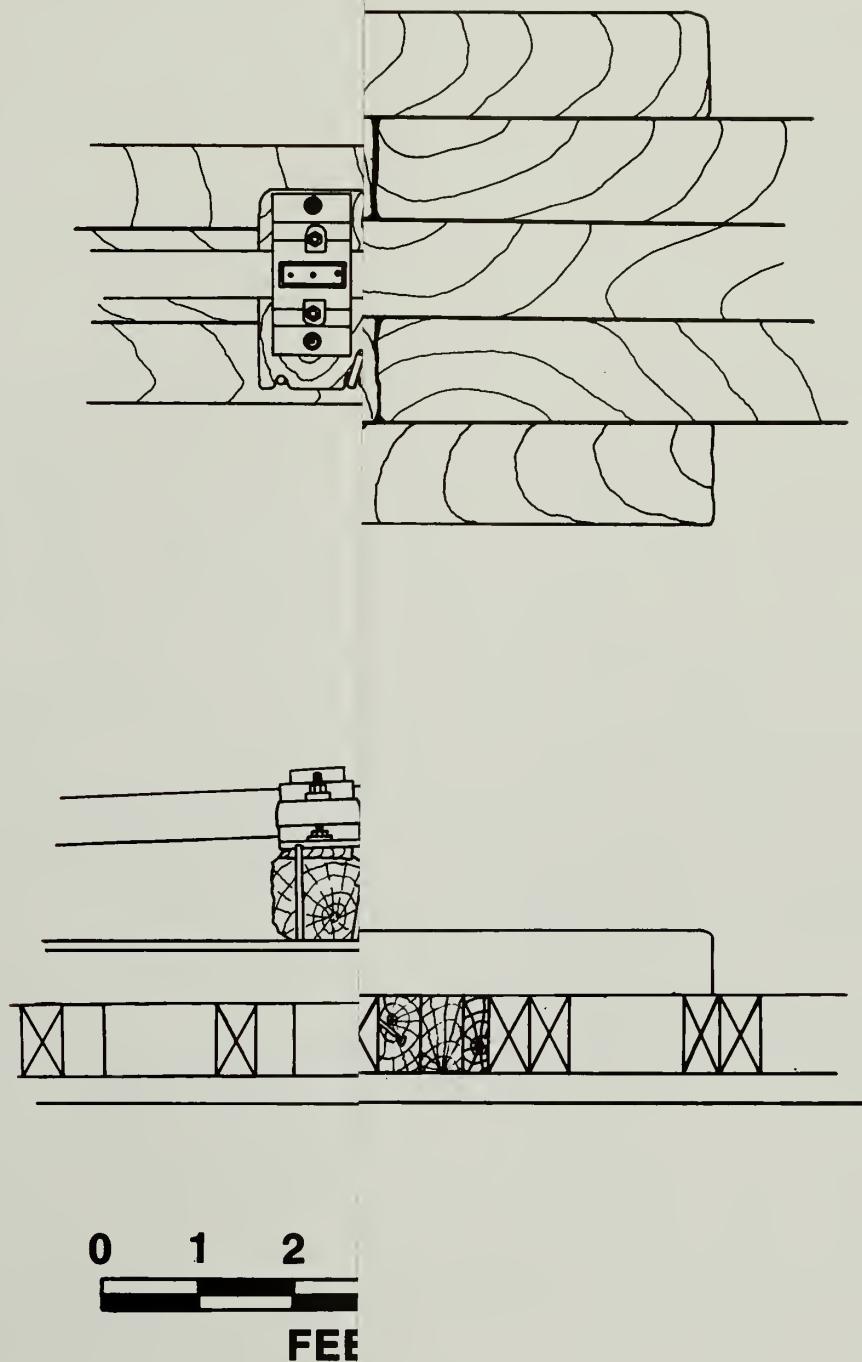
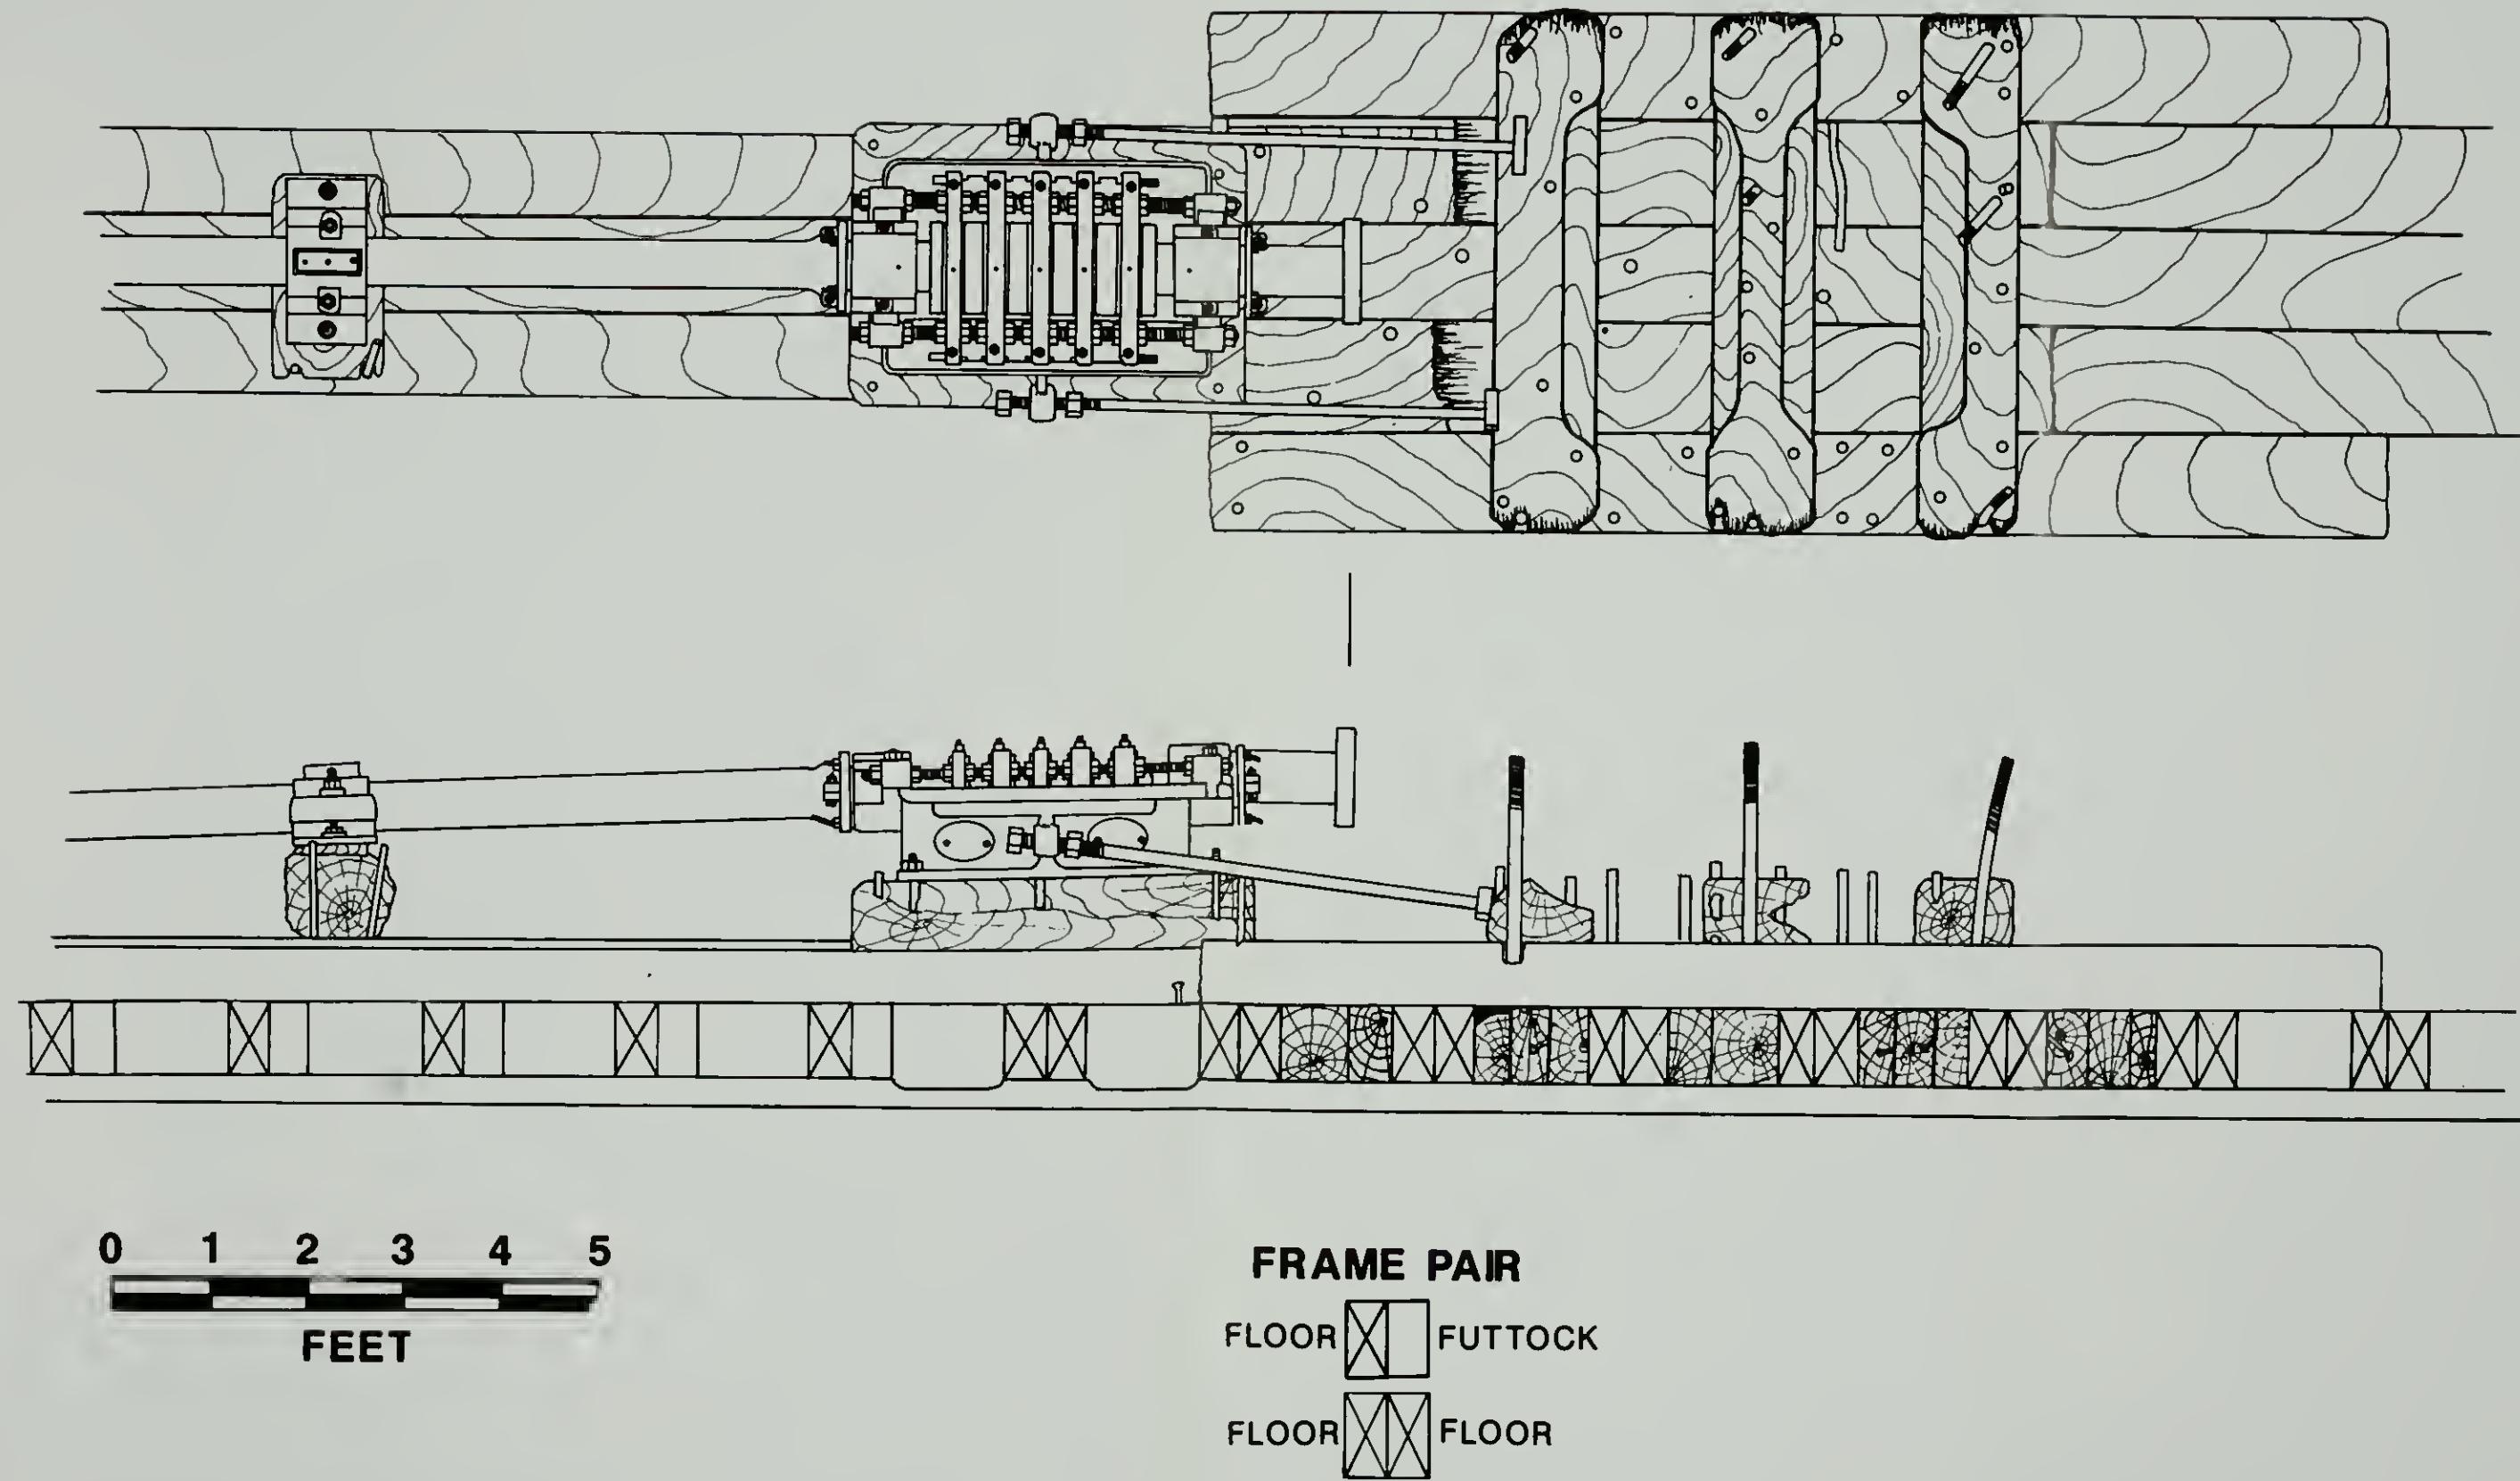
Figure 5.31. Plan and elevation of engine bed and thrust bearing showing additional frames to support engine weight. Drawing by Jim Bradford.

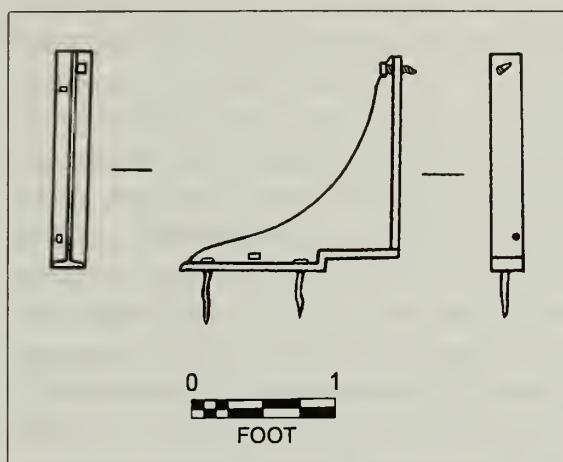
The only evidence remaining of *E. C. Waters*' engine is the wooden engine bed and the bolts that secured the engine to the bed. The boiler is represented by four iron or steel saddles (Figures 5.32 and 5.33) that supported the boiler and served to distribute the concentrated weight of the boiler and its water over a larger area through the main keelson and other wooden members of the hull. These four saddles are scattered in the general debris within the vessel's hull, a pattern most likely the result of salvage activity. Each saddle is triangular with one concave side to accept the rounded boiler shell, and is notched on one edge for mounting in the hull. There is no evidence of direct fastening

Figure 5.32. Side and end views of boiler saddle. Drawing by Jim Bradford.

of the boiler to the saddles, indicating metal straps or stays with turnbuckles may have been used to secure the boiler to the vessel.

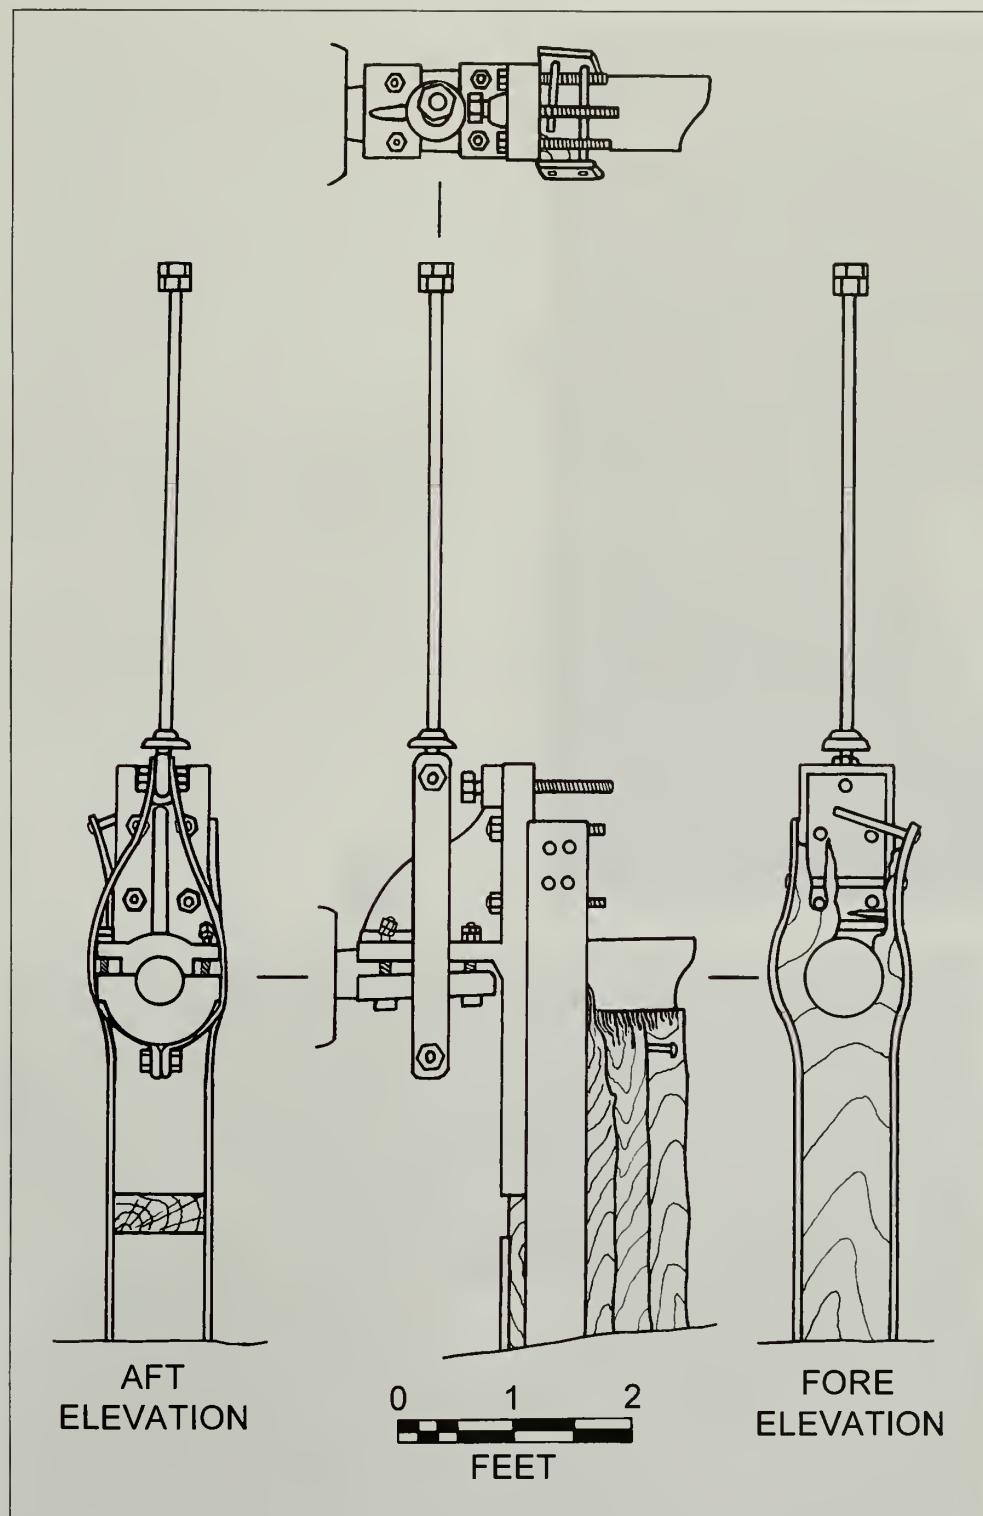
E. C. Waters' propeller is typical of lake steamers. It is cast iron with four blades, though two blades are broken off about 1 ft. from the hub, or boss (Figures 5.41 and 5.42). The two

Figure 5.40. Plan, starboard elevation, fore and aft views of adjustable stern bearing assembly. Drawing by Jim Bradford.

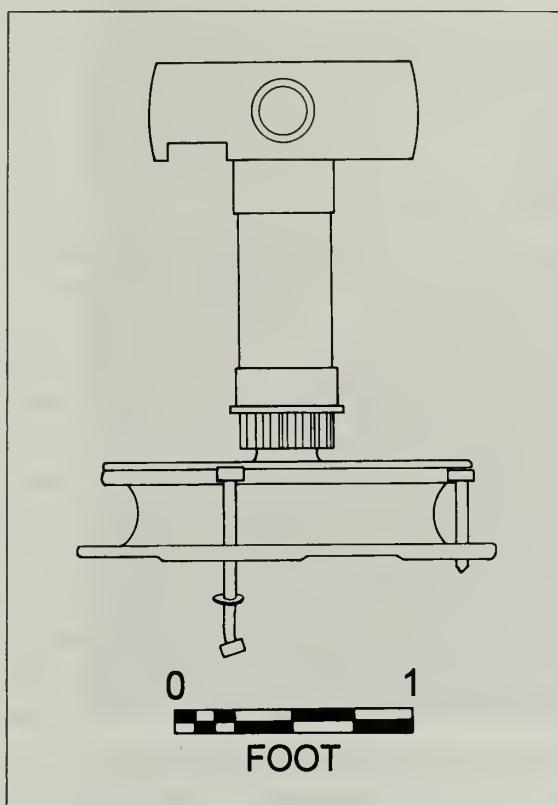
E. C. Waters' capstan is located 75 ft. south of the engine bed, buried in the sand in about 1½ ft. of water (Figures 5.46 and 5.47). Before 1995, the capstan was located on the beach about 30 ft. south-southwest of the wreck. During SCRU's 1995 visit, the capstan was not located and thought by park rangers to be missing. A depression on the beach marked the location where park rangers remembered it (Lenihan 1995b:5). During the present site documentation, the capstan was found in its current location, apparently moved by would-be looters in a failed attempt to remove it. The capstan is 1 ft. 3 in. high, 1 ft. 4 in. across the drumhead, and its base is 2 ft. 2 in. in diameter. The base plate, spindle, and drumhead are intact,

Figure 5.46. Scale drawing of *E. C. Waters'* capstan. Drawing by Matt Russell.

but the barrel is missing. The capstan is geared, indicating it was probably operated with an auxiliary steam engine.
